**Flood Control Project Maintenance
Levee Inspections**

Fall 2016 Levee Maintenance Deficiency Summary Report

Sacramento River Basin

Sutter Maintenance Yard Maintenance Area 0012

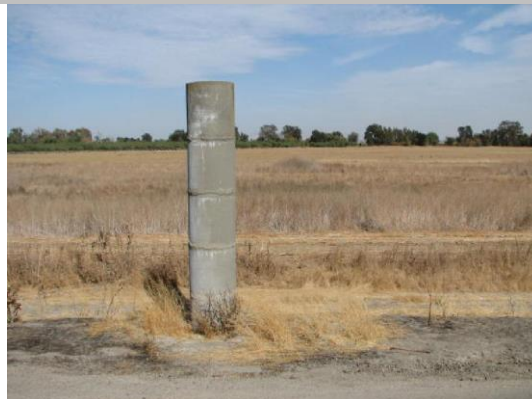
Photo 1 of 1 : UCIP_FA_2016_50389_68970.jpg

Comment Code					
Inspector Comment					
FS_ID:50389 DS_ID:17145 EP_NO: 9381 Repair Type: Non-Urgent Crossing Status: Indicator Found UCIP Comments: 10/17/2016 Abandoned (DWR Sutter Yard-AFreitag)5/31/2016 Abandoned- only the LS concrete standpipe was found.5/4/2015 Abandoned crossing.6/17/2014 Same as last inspection.12/16/2013 Same as last inspection.7/16/2013 Same as last inspection.10/11/2012 Need to verify proper abandonment of pipe. FIELD_STRUCT_DESC: *ABANDONED* 14-inch steel irrigation pipe through the levee, 3 feet below the crown. Open on the waterside (WS) end. 3-foot by 6-foot concrete well on the WS berm. Siphon breaker in 24-inch pipe riser located on the landside (LS) shoulder. 36-inch concrete stand pipe on the LS berm. The only item identified is the 36-inch standpipe on the LS toe (Automatic Board Order (ABO) issued as Permit No. 9381, 1974 - Tribble). [Additional Reference(s): DWR Levee Log, 2005. USACE Sacramento O&M Manual 132, October 1959 (HLM 0.22, Drawing No. 50-4-3081)] FS Date: 10/17/2016 1:09:05 PM

36-inch concrete riser on LS toe.

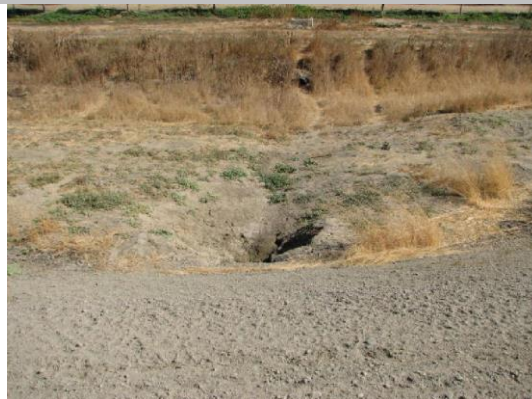
Photo 1 of 2 : UCIP_FA_2016_50391_68973.jpg

FS_ID:50391
DS_ID:17146
EP_NO: 9382
Repair Type: Non-Urgent
Crossing Status: Found
UCIP Comments: 10/17/2016 Minor sediment blocking the WS flap gate from opening. LS inlet still mostly full of sediment.(DWR Sutter Yard- AFreitag)9/29/2016 Crossing has been downgraded from Urgent to Non-Urgent WS flap gate is closed for flood season. Need to coordinate with owner to remove sediment blocking WS flap gate. (DWR UCIP - omagana)5/31/2016 WS flap gate is blocked from opening by sediment. LS inlet is over 50% full of sediment. (DWR Sutter Yard - afreitag)5/4/2015 WS flap gate is blocked by sediment and unable to open. LS inlet is about 50% plugged with soil. Needs to be cleaned. (DWR Sutter Yard - afreitag)6/17/2014 Same as last inspection. (DWR Sutter Yard - afreitag)12/16/2013 Sediment against flapgate has been cleared and it can now function properly. (DWR Sutter Yard - afreitag)7/16/2013 Sediment is built up against WS flapgate preventing it from opening. (DWR Sutter Yard - afreitag)10/11/2012 Pipe is partially filled with soil. (DWR UCIP - wwylie)

Intake at LS toe.

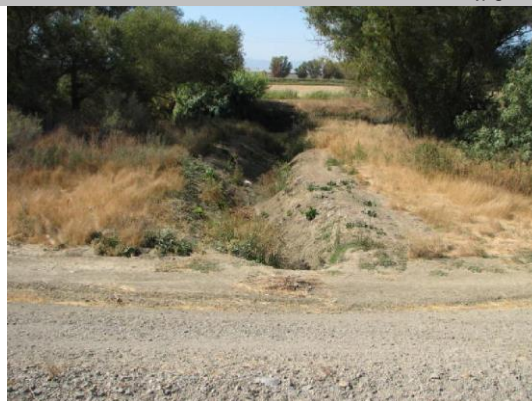
Photo 2 of 2 : UCIP_FA_2016_50391_68972.jpg

FS_ID:50391
DS_ID:17146
EP_NO: 9382
Repair Type: Non-Urgent
Crossing Status: Found
UCIP Comments: 10/17/2016 Minor sediment blocking the WS flap gate from opening. LS inlet still mostly full of sediment.(DWR Sutter Yard- AFreitag)9/29/2016 Crossing has been downgraded from Urgent to Non-Urgent WS flap gate is closed for flood season. Need to coordinate with owner to remove sediment blocking WS flap gate. (DWR UCIP - omagana)5/31/2016 WS flap gate is blocked from opening by sediment. LS inlet is over 50% full of sediment. (DWR Sutter Yard - afreitag)5/4/2015 WS flap gate is blocked by sediment and unable to open. LS inlet is about 50% plugged with soil. Needs to be cleaned. (DWR Sutter Yard - afreitag)6/17/2014 Same as last inspection. (DWR Sutter Yard - afreitag)12/16/2013 Sediment against flapgate has been cleared and it can now function properly. (DWR Sutter Yard - afreitag)7/16/2013 Sediment is built up against WS flapgate preventing it from opening. (DWR Sutter Yard - afreitag)10/11/2012 Pipe is partially filled with soil. (DWR UCIP - wwylie)

Outlet at WS toe.

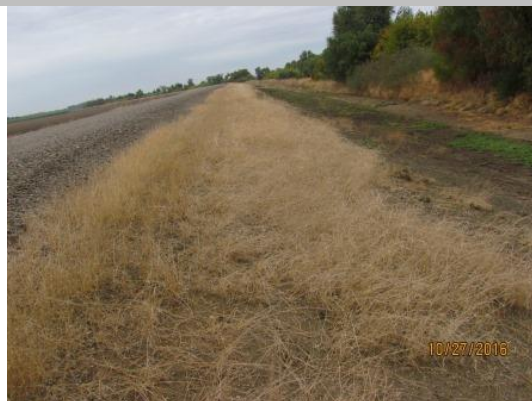
Photo 1 of 1 : FA_2016_MA0012_299_36_20161107_00040.jpg

View of the annual grass along the waterside slope.

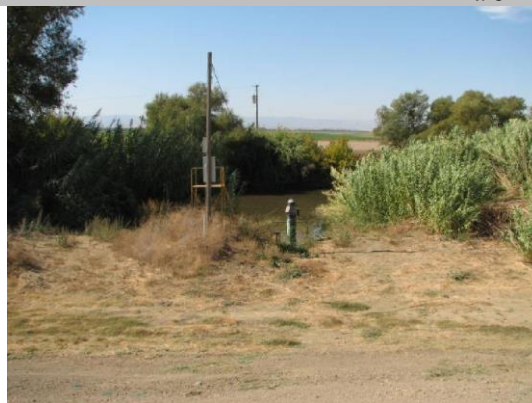
Photo 1 of 2 : UCIP_FA_2016_50393_68981.jpg

Comment Code					
Inspector Comment					
FS_ID:50393 DS_ID:17148 EP_NO: 9382 Repair Type: Non-Urgent Crossing Status: Found UCIP Comments: 10/17/2016 Vegetation is overgrowing the WS head wall near the pump. The rest of the crossing appears to be in good condition. (DWR Sutter Yard- A Freitag) 5/31/2016 Crossing appears to be in good condition. 5/4/2015 Crossing appears in good condition. No noticeable issues to report. 6/17/2014 Same as last inspection. 12/16/2013 Same as last inspection. 7/16/2013 Same as last inspection. FIELD_STRUCT_DESC: 18-inch steel irrigation pipe through the levee, 3 feet below the crown. Pump, butterfly valve, and concrete headwall at the edge of bank. Bank cobble re-vetted 10 feet on both waterside (WS) and landside (LS) of installation. 18-inch polyvinyl chloride (PVC) standpipe on the LS berm. Siphon breaker in 18-inch concrete riser on the LS shoulder. Service pole at the edge of the bank. (Automatic Board Order (ABO) issued as Permit No. 9382, 1974 - Baber) [Additional Reference(s): DWR Levee Log, 2005. USACE Sacramento O&M Manual 132, October 1959 (HLM 1.53)] FS Date: 10/17/2016 1:16:24 PM

Pump, pole, and meter on WS toe.

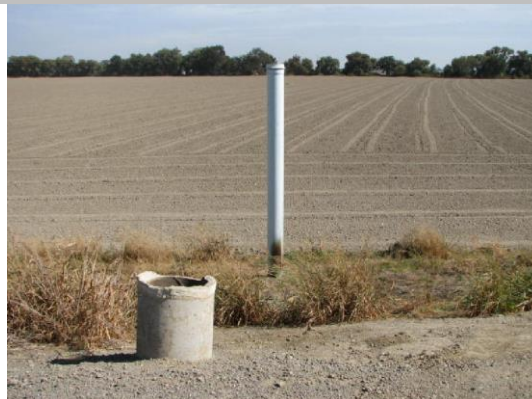
Photo 2 of 2 : UCIP_FA_2016_50393_68980.jpg

Concrete and PVC risers on LS.

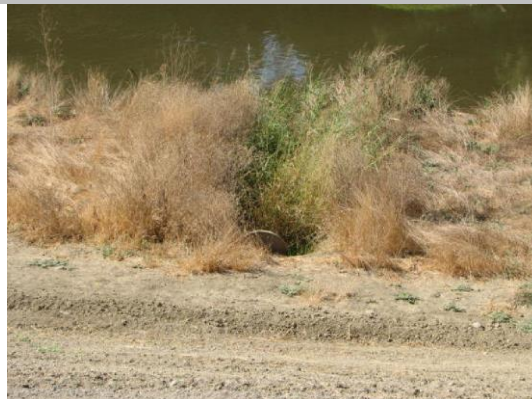
Photo 1 of 2 : UCIP_FA_2016_50394_68984.jpg

FS_ID:50394
DS_ID:17149
EP_NO: 9382
Repair Type: Non-Urgent
Crossing Status: Found
UCIP Comments: 10/17/2016 Crossing appears to be in good condition. This is a gravity drain for the LS. (DWR Sutter Yard-AFreitag)5/31/2016 LS inlets was partially plugged. WS flapgate was clear of sediment and able to operate properly.5/4/2015 WS flapgate is blocked by sediment and unable to open. LS inlet is plugged by silt and wood chippings. Needs to be cleaned.6/17/2014 Flap gate was cleaned out and is fully closed. LS inlet still partially full of soil.12/16/2013 Same as last inspection. WS flapgate still needs to be cleaned out and shut.7/16/2013 Same as last inspection. Make sure flapgate is closed before highwater season.10/11/2012 Inlet on LS filled partially with soil. Outlet blocked with soil and the flap gate wont close.
FIELD_STRUCT_DESC: 24-inch corrugated metal drainage pipe through the levee, 13 feet below the crown. Flap gate, concrete headwall and grouted cobble spillway on the waterside (WS). Concrete headwall located on the landside (LS). (Automatic Board Order (ABO) issued as Permit No. 9382, 1974 - Baber). [Additional Reference(s): DWR Levee Log, 2005. USACE Sacramento O&M Manual 132, October 1959 (HLM 1.72)]

Outlet on WS toe.

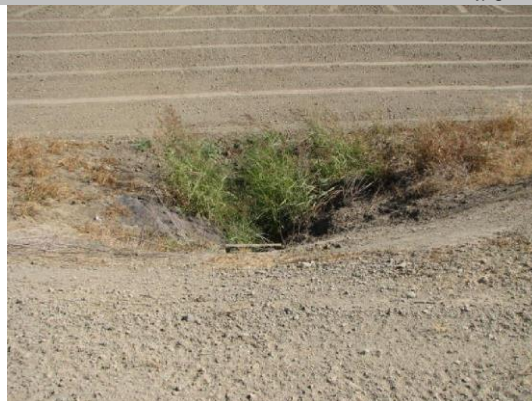
Photo 2 of 2 : UCIP_FA_2016_50394_68983.jpg

Inlet on LS toe.

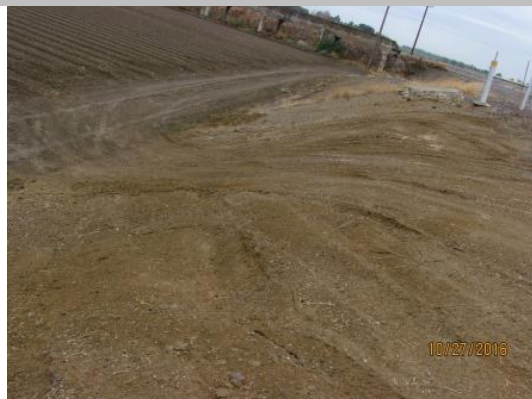
Photo 1 of 1 : FA_2016_MA0012_299_35_20161107_00041.jpg

LM Start	1.81	Rating **	M	Issue No.	35
LM End	1.81	Issue Type +	Ma	Location *	LS
Category	Earthen Levee			GPS Latitude/Longitude	
				Start	End
Item	Slope Stability			39.057393 °	39.057393 °
				-122.003452 °	-122.003452 °
DWR ID	DWR_MA0012_01_f_2016_35				
Comment Code					
S3 : Repair the levee slope damaged by vehicle traffic and prevent access where possible.					
Inspector Comment

View of the slope instability caused by vehicles along the landside slope.

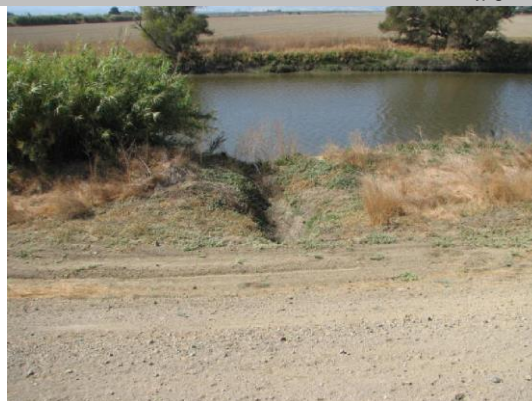
Photo 1 of 2 : UCIP_FA_2016_50398_68994.jpg

Comment Code					
Inspector Comment					
FS_ID:50398 DS_ID:17151 EP_NO: 9391 Repair Type: Non-Urgent Crossing Status: Found UCIP Comments: 10/17/2016 Appears abandoned. Both pipe ends are completely buried. (DWR Sutter Yard- AFreitag)9/29/2016 Crossing has been downgraded from Urgent to Non-Urgent both pipe ends are buried. Having both ends buried prevents water from flowing from WS to LS during flood season. Need to contact owner and have owner coordinate with CVFPB to comply with Title 23. (DWR UCIP - omagana)5/31/2016 Both pipe ends are buried. Pipe is non-operational. (DWR Sutter Yard - afreitag)5/4/2015 LS and WS ends are blocked with soil. Pipe is inoperable as it is. (DWR Sutter Yard - afreitag)6/17/2014 Same as last inspection. (DWR Sutter Yard - afreitag)12/16/2013 Same as last inspection. (DWR Sutter Yard - afreitag)7/16/2013 LS inlet is completely filled with soil. Needs to be cleaned out. (DWR Sutter Yard - afreitag)10/11/2012 Inlet is partially filled with soil. (DWR Sutter Yard - wwylie) FIELD_STRUCT_DESC: *ABANDONED* 24-inch corrugated metal drainage pipe through the levee, 13 feet below the crown. Flap gate, concrete headwall and grouted cobble spillway on the waterside (WS). Concrete headwall located on the landside (LS). (Automatic Board Order (ABO) issued as Permit No. 9391, Christenson). [Additional Reference(s): DWR Levee Log, 2005. USACE Sacramento O&M Manual 132, October 1959 (HLM 2.02)] FS Date: 10/17/2016 1:20:06 PM

WS view of outlet.

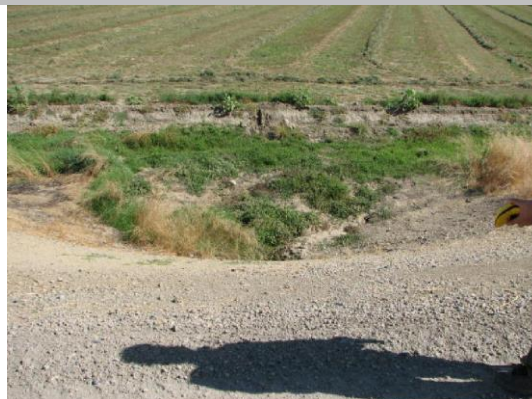
Photo 2 of 2 : UCIP_FA_2016_50398_68993.jpg

LS view of inlet.

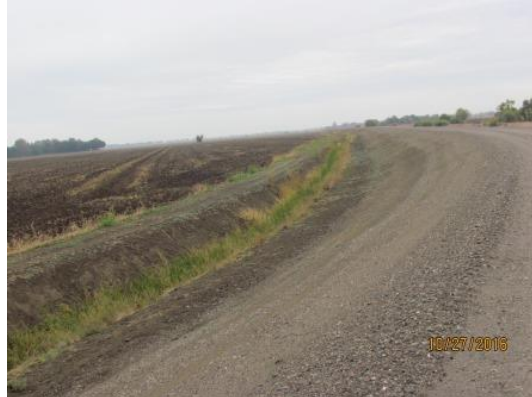
Photo 1 of 1 : FA_2016_MA0012_299_34_20161107_00042.jpg

View of a ditch along the landside toe.

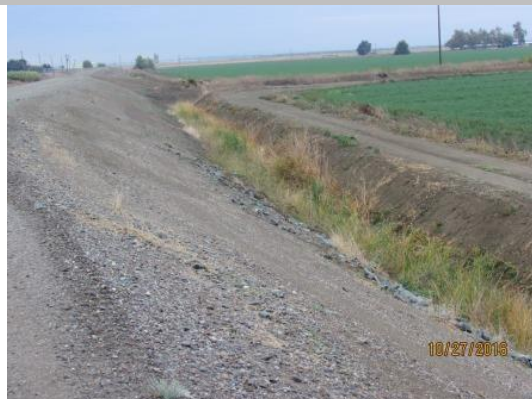
Photo 1 of 1 : FA_2016_MA0012_299_1_20161107_00043.jpg

LM Start	3.01	Rating **	U	Issue No.	1
LM End	3.68	Issue Type +	En	Location *	LS
Category	Earthen Levee			GPS Latitude/Longitude	
				Start	End
Item	Encroachments			39.072267 °	39.081684 °
				-122.014453 °	-122.016243 °
DWR ID	DWR_MA0012_01_s_2012_1				
Comment Code					
DT : Ditch					
Inspector Comment

View of a ditch along the landside toe.

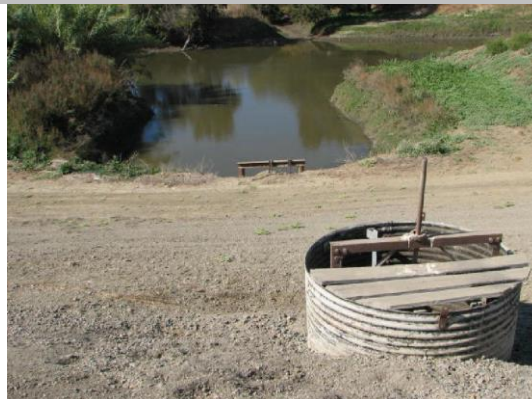
Photo 1 of 2 : UCIP_FA_2016_50401_69005.jpg

FS_ID:50401
DS_ID:17154
EP_NO: 9388
Repair Type: Urgent
Crossing Status: Found
UCIP Comments: 10/17/2016 Slide gate stem is still and the gate appears to be inoperable. (DWR Sutter Yard- AFreitag)5/31/2016 Slide gate stem is still bent. WS flap gate is chained open. (DWR Sutter Yard - afreitag)5/4/2015 Slide gate stem is still bent. Gate looks to be unable to close all the way. (DWR Sutter Yard - afreitag)6/17/2014 Same as last inspection. (DWR Sutter Yard - afreitag)12/16/2013 Slide gate stem is still bent. WS flapgate was closed. (DWR Sutter Yard - afreitag)7/16/2013 Water flowing through pipe so screw gate definately not closed. Was told NOV's have been sent for owner to replace stem. Flap gate gets closed for flood season. (DWR Sutter Yard - afreitag)10/11/2012 Slide gate inoperable, but appears to be in closed position. Flap gate held in open position. Good candidate for video inspection when, if ever, dry. (DWR UCIP - wwylie)

Slide gate in corrugated metal riser on WS slope.

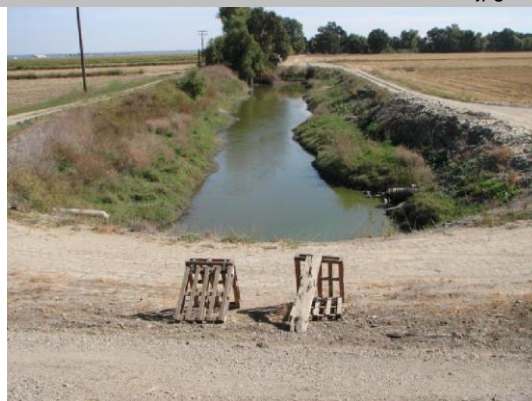
Photo 2 of 2 : UCIP_FA_2016_50401_69004.jpg

Drainage ditch on LS toe.

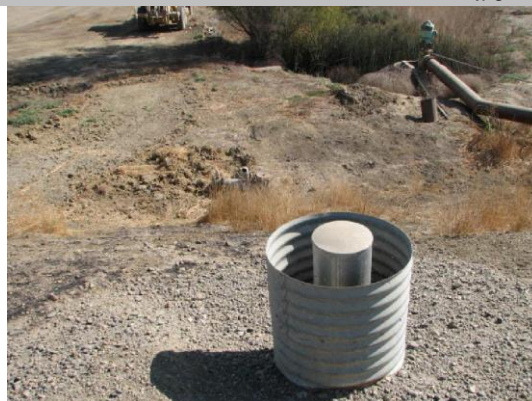
Photo 1 of 2 : UCIP_FA_2016_50406_69023.jpg

FS_ID:50406
DS_ID:20717
EP_NO: N/A
Repair Type: Non-Urgent
Crossing Status: Found
UCIP Comments: 10/17/2016 Crossing appears to be in good condition. (DWR Sutter Yard- A Freitag) 5/31/2016 Crossing appears to be in good condition. 5/4/2015 Crossing appears to be in good condition. No noticeable issues to report. 6/17/2014 Same as last inspection. Pump reinstalled on pier. 12/16/2013 Pump has been removed for winter. 7/16/2013 Same as last inspection. 10/11/2012 No permit identified for this crossing.
FIELD_STRUCT_DESC: 24-inch asphalt coated steel irrigation pipe through levee, 4.5 feet below the crown. Pump in pump house located on the waterside (WS) bank. Siphon breaker valve installed on the landside (LS) shoulder. No permit has been identified since crossing was field discovered in 2012.
FS Date: 10/17/2016 1:27:14 PM

Possible siphon breaker for pipe on LS shoulder.

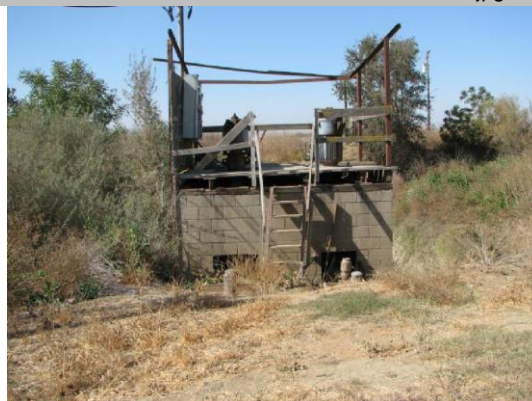
Photo 2 of 2 : UCIP_FA_2016_50406_69022.jpg

Pumping plant on WS toe.

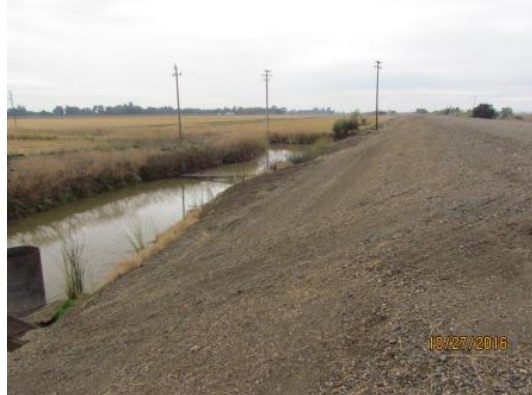
Photo 1 of 1 : FA_2016_MA0012_299_4_20161107_00044.jpg

View of a ditch along the landside toe.

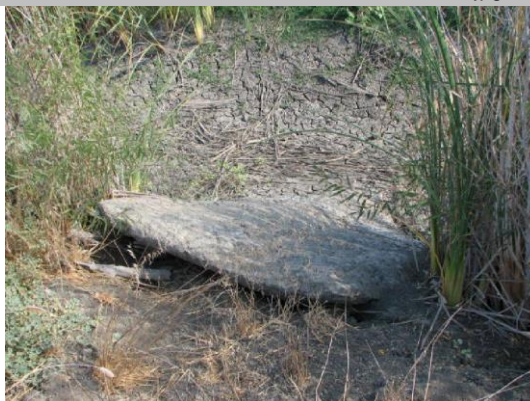
Photo 1 of 2 : UCIP_FA_2016_50408_69030.jpg

Comment Code					
Inspector Comment					
FS_ID:50408 DS_ID:17191 EP_NO: N/A Repair Type: Non-Urgent Crossing Status: Found UCIP Comments: 10/17/2016 WS flap gate is still silted over and LS inlet is heavily vegetated and unable to be inspected. (DWR Sutter Yard- AFreitag)9/29/2016 Crosssing has been downgraded from Urgent to Non-Urgent WS flap gate is closed shut due to sediment build up. For flood season flap gate is required to be closed. Need to coordinate with owner to remove sediment from WS to have WS flap gate be operable after flood season. (DWR UCIP - omagana)5/31/2016 WS pipe end was mostly underwater but it appears to still be silted over. (DWR Sutter Yard - afreitag)5/4/2015 WS flapgate is blocked by sediment and unable to open. LS inlet is hidden by sediment and heavy vegetation and unable to be located. Needs to be cleared. (DWR Sutter Yard - afreitag)6/17/2014 Same as last inspection. (DWR Sutter Yard - afreitag)12/16/2013 Same as last inspection. (DWR Sutter Yard - afreitag)7/16/2013 Same as last inspection. (DWR Sutter Yard - afreitag)10/11/2012 Pipe is clogged at both the inlet and outlet. Good candidate for video inspection. (DWR UCIP - wwylie) FIELD_STRUCT_DESC: 48-inch corrugated metal drainage pipe through the levee, approximately 15 feet below the crown. Concrete headwalls on both the waterside (WS) and (LS) ends with an automatic drainage gate on the WS. [Additional Reference(s): USACE Sacramento O&M Manual 132, October 1959 (HLM 5.12)] FS Date: 10/17/2016 1:29:34 PM

Apparent inlet clogged with concrete or grout on LS toe in drainage swale.

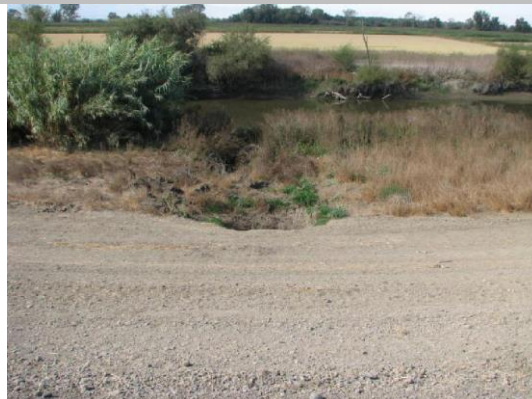
Photo 2 of 2 : UCIP_FA_2016_50408_69029.jpg

Outlet on WS toe.

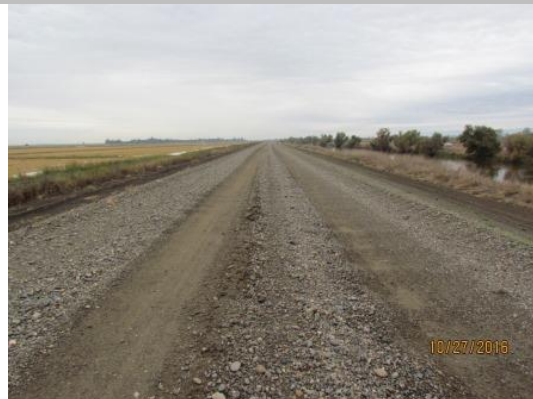
Photo 1 of 1 : FA_2016_MA0012_299_33_20161107_00045.jpg

View of minor ruts on the levee crown

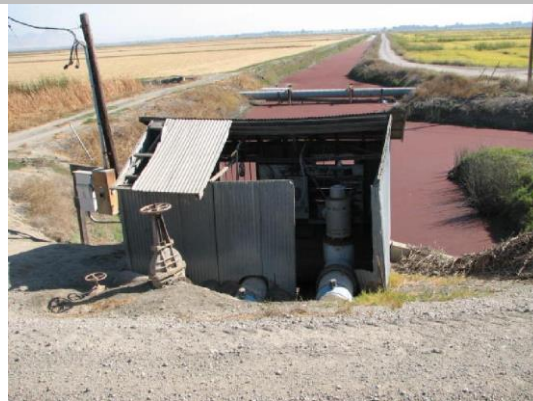
Photo 1 of 2 : UCIP_FA_2016_50411_69061.jpg

Comment Code					
Inspector Comment					
FS_ID:50411 DS_ID:20715 EP_NO: 13699 Repair Type: Non-Urgent Crossing Status: Found UCIP Comments: 10/17/2016 Crossing appears to be in good condition. 5/31/2016 Crossing appears to be in good condition.5/4/2015 Corssing appears to be in good condition. No noticeable issues to report.6/17/2014 Same as last inspection.12/16/2013 Same as last inspection.7/16/2013 Same as last inspection.10/11/2012 Oil leakage around pump. FIELD_STRUCT_DESC: 1 of 2: 20-inch soilproofed steel drainage pipe through the levee, 4.4 feet below the crown. Cobble revetted sump located on the waterside (WS). Siphon breaker in 24-inch metal pipe risers on the WS shoulder. Pump house at toe of landside (LS) slope. This crossing replaces the previous 18-inch pipe listed in the USACE Sacramento O&M manual (HLM 6.13), see DS_ID 17162. (Permit No. 13699, 1984 - Davis Ranches) FS Date: 10/17/2016 1:32:51 PM

Pumping plant on LS slope

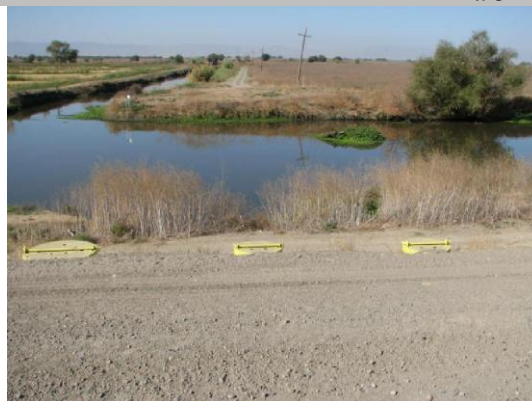
Photo 2 of 2 : UCIP_FA_2016_50411_69060.jpg

Siphon Breaker on WS shoulder.

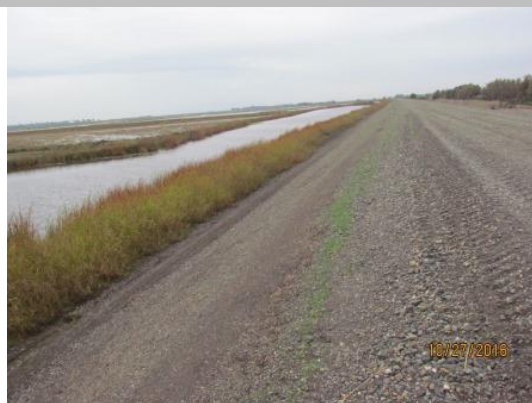
Photo 1 of 1 : FA_2016_MA0012_299_37_20161107_00046.jpg

LM Start	6.02	Rating **	U	Issue No.	37
LM End	7.20	Issue Type +	En	Location *	LS
Category	Earthen Levee			GPS Latitude/Longitude	
				Start	End
Item	Encroachments			39.115518 °	39.131618 °
				-122.017908 °	-122.022785 °
DWR ID	DWR_MA0012_01_f_2016_37				
Comment Code					
DT : Ditch					
Inspector Comment

View of a ditch along the landside toe.

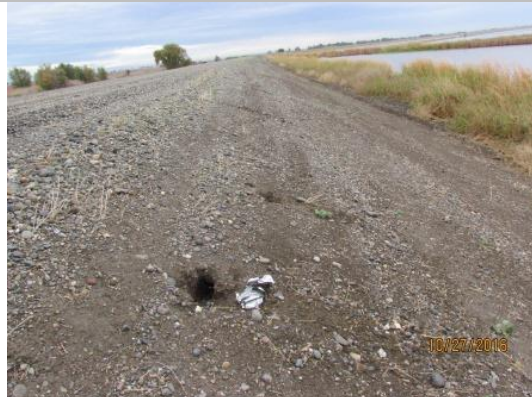
Photo 1 of 1 : FA_2016_MA0012_299_32_20161107_00047.jpg

View of the rodent holes along the landside slope.

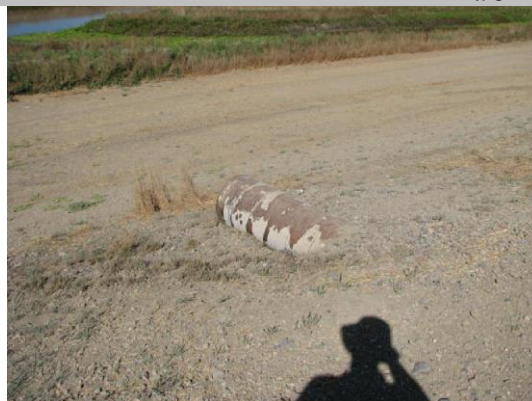
Photo 1 of 2 : UCIP_FA_2016_50417_69089.jpg

FS_ID:50417
DS_ID:17163
EP_NO: 9390
Repair Type: Non-Urgent
Crossing Status: Found
UCIP Comments: 10/17/2016 Appears abandoned and should be removed. (DWR Sutter Yard- A Freitag) 5/31/2016 Appears to be abandoned. Pipe is capped on both WS and LS ends. 5/4/2015 Crossing appears to be in good condition. No noticeable issues to report. 6/17/2014 Same as last inspection. 12/16/2013 Same as last inspection. 7/16/2013 Same as last inspection. 10/11/2012 Rodent burrowing along sides of pipe on LS.
FIELD_STRUCT_DESC: 24-inch steel irrigation pipe through the levee, 3 feet below the crown. Both ends capped, terminating on levee slopes. (Automatic Board Order (ABO) issued as Permit No. 9390, 1974 - Profpe) [Additional Reference(s): DWR Levee Log, 2005. USACE Sacramento O&M Manual 132, October 1959 (HLM 7.76)]
FS Date: 10/17/2016 1:35:45 PM

Pipe on WS.

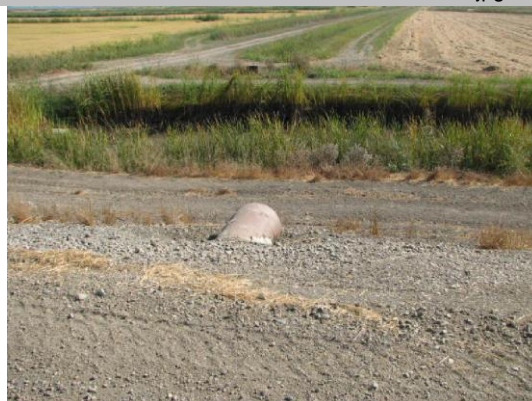
Photo 2 of 2 : UCIP_FA_2016_50417_69088.jpg

Pipe on LS.

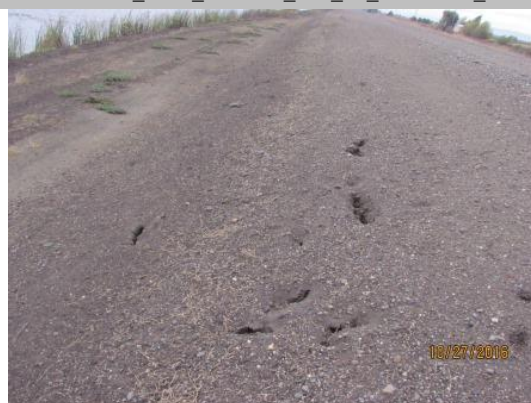
Photo 1 of 1 : FA_2016_MA0012_299_28_20161107_00049.jpg

LM Start	8.84	Rating **	A/W	Issue No.	28
LM End	8.84	Issue Type +	Ob	Location *	LS
Category	Earthen Levee			GPS Latitude/Longitude	
				Start	End
Item	Slope Stability			39.155365 °	39.155365 °
				-122.021675 °	-122.021675 °
DWR ID	DWR_MA0012_01_f_2016_28				
Comment Code					
S1 : Repair slope instability.					
Inspector Comment					
Longitudinal cracks caused by fat clay. Cracks are 18" to 24" deep at places.

View of the longitudinal cracks along the landside slope.

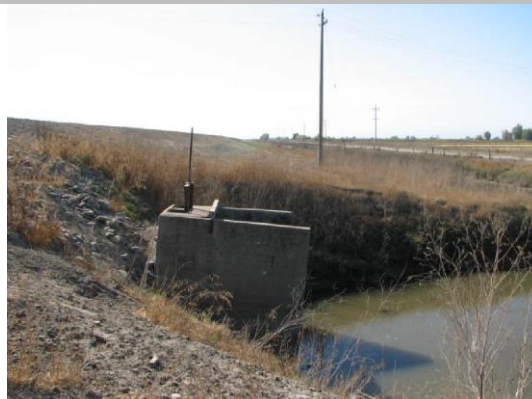
Photo 1 of 2 : UCIP_FA_2016_50419_69100.jpg

FS_ID:50419
DS_ID:17166
EP_NO: 9390
Repair Type: Urgent
Crossing Status: Found
UCIP Comments: 10/17/2016 WS concrete headwall is still tiltig away from the levee. (DWR Sutter Yard- AFreitag)5/31/216 Ws concrete headwall is still tilting away from the levee and towards the WS ditch. (DWR Sutter Yard - afreitag)5/4/2015 WS concrete headwall tilting away from the levee slope. (DWR Sutter Yard - afreitag)6/17/2014 Same as last inspection. (DWR Sutter Yard - afreitag)12/16/2013 Same as last inspection. (DWR Sutter Yard - afreitag)7/16/2013 Same as last inspection. (DWR Sutter Yard - afreitag)10/11/2012 Concrete Headwall tilting on WS slope. (DWR UCIP - wwylie)
FIELD_STRUCT_DESC: 36-inch corrugated metal drainage pipe through the levee, 15 feet below the crown. Concrete head wall, slide gate and grouted revetment on the waterside (WS). Slide gate and concrete headwall located on the landside (LS). (Automatic Board Order (ABO) issued as Permit No. 9390, 1974 - Profpe). [Additional Reference(s): DWR Levee Log, 2005. USACE Sacramento O&M Manual 132, October 1959 (HLM 9.24)]

Tilting headwall on WS toe.

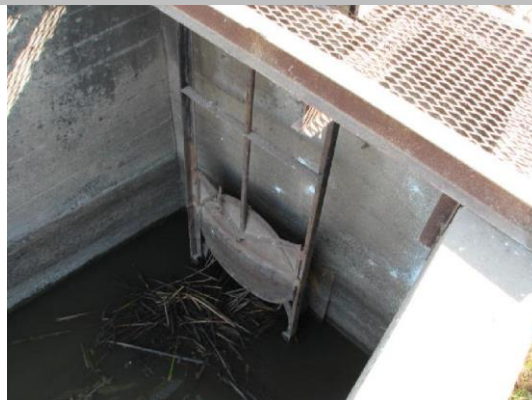
Photo 2 of 2 : UCIP_FA_2016_50419_69099.jpg

Slidegate on WS toe.

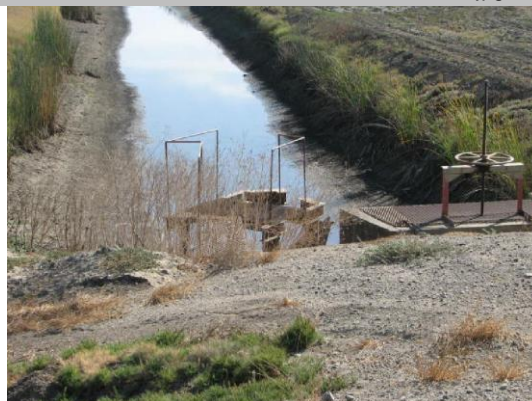
Photo 1 of 2 : UCIP_FA_2016_50420_69109.jpg

FS_ID:50420
DS_ID:17165
EP_NO: 9390
Repair Type: Non-Urgent
Crossing Status: Indicator Found
UCIP Comments: 10/17/2016 Abandoned. (DWR Sutter Yard-AFreitag)5/31/2016 Abandoned crossing.5/4/2015 Abandoned crossing.6/17/2014 Same as last inspection.12/16/2013 Same as last inspection.7/16/2013 Same as last inspection.10/11/2012 Pipe abandoned. Steel pump platform remains on LS slope, but all appurtenances have been removed.
FIELD_STRUCT_DESC: *ABANDONED* 18-inch steel pipe through the levee, 3 feet below the crown. Waterside (WS) end open into concrete spill box. Pump located on the landside (LS) on steel pier. (Automatic Board Order (ABO) issued as Permit No. 9390, 1974 - Profpe)
[Additional Reference(s): DWR Levee Log, 2005. USACE Sacramento O&M Manual 132, October 1959 (HLM 9.24)]
FS Date: 10/17/2016 1:55:46 PM

Pump platform at center left of photo.

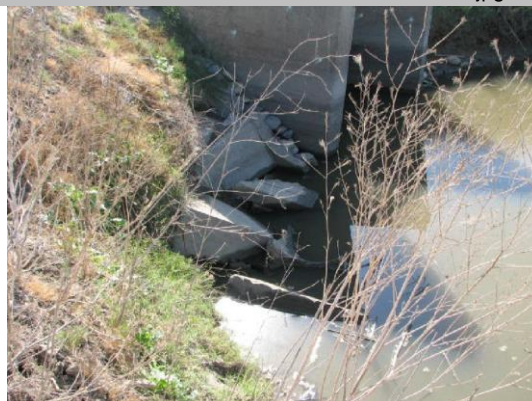
Photo 2 of 2 : UCIP_FA_2016_50420_69108.jpg

headwall debris on LS toe showing evidence of 18-inch cmp.

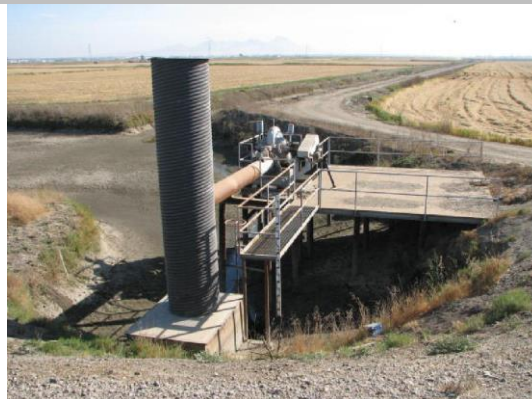
Photo 1 of 2 : UCIP_FA_2016_50422_69112.jpg

Comment Code					
Inspector Comment					
FS_ID:50422 DS_ID:17167 EP_NO: 9389 Repair Type: Urgent Crossing Status: Found UCIP Comments: 10/17/2016 WS flapgate has seperated from the pipe end. WS pipe end is showing signs of rust and deterioration. Needs a new flapgate or other means of closing off the pipe before flood season. (DWR Sutter Yard- A/Freitag)5/31/2016 Crossing appears to be in good condition.5/4/2015 Corssing appears to be in good condition. No noticeable issues to report.6/17/2014 Same as last inspection.12/16/2013 Same as last inspection.7/16/2013 Same as last inspection. FIELD_STRUCT_DESC: 36-inch corrugated metal drainage pipe through the levee, 15.4 feet below the crown. Concrete headwall and flap gate located on the waterside (WS). Concrete headwall located on the landside (LS). Pump on steel structure in slough on the LS discharges into 42-inch corrugated metal pipe riser. Service pole on ramp. Butterfly gate at inlet on the LS toe. (Automatic Board Order (ABO) issued as Permit No. 9389, 1974 - Propfe) [Additional Reference(s): DWR Levee Log, 2005. USACE Sacramento O&M Manual 132, October 1959 (HLM 9.33)] FS Date: 10/17/2016 1:56:47 PM

Pumping plant on LS toe.

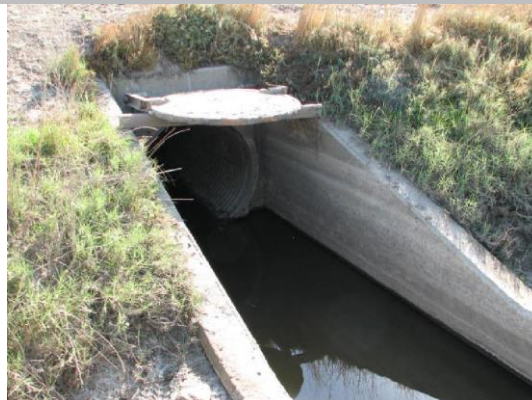
Photo 2 of 2 : UCIP_FA_2016_50422_69111.jpg

Flap gate and headwall on WS toe.

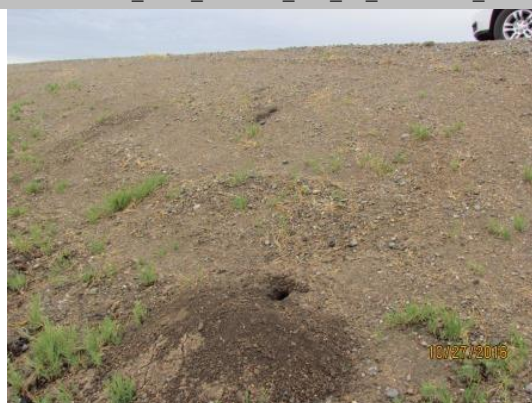
Photo 1 of 1 : FA_2016_MA0012_299_24_20161107_00048.jpg

LM Start	9.29	Rating **	C	Issue No.	26
LM End	9.29	Issue Type +	Ma	Location *	LS
Category	Earthen Levee			GPS Latitude/Longitude	
				Start	End
Item	Animal Control			39.161847 °	39.161847 °
				-122.021895 °	-122.021895 °
DWR ID	DWR_MA0012_01_f_2015_26				
Comment Code					
A3 : No rodents visible, but rodent burrows visible; need to backfill and compact or grout burrows.					
Inspector Comment					
Repair the rodent holes on the landside slope.

View of the rodent holes along the landside slope.

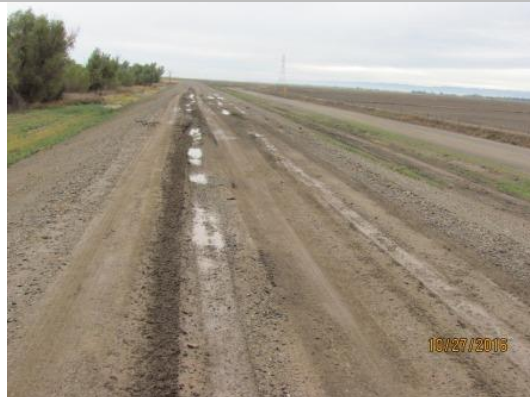
Photo 1 of 1 : FA_2016_MA0012_299_23_20161107_00050.jpg

LM Start	10.69	Rating **	U	Issue No.	23
LM End	10.73	Issue Type +	Ma	Location *	CR
Category	Earthen Levee			GPS Latitude/Longitude	
				Start	End
Item	Crown Surface / Depressions / Rutting			39.176778 °	39.177313 °
				-122.014340 °	-122.014380 °
DWR ID	DWR_MA0012_01_s_2016_23				
Comment Code					
C2 : Repair depressions or ruts in the crown or slope.					
Inspector Comment					
Ruts are 6" deep at places.

View of the ruts on the levee crown.

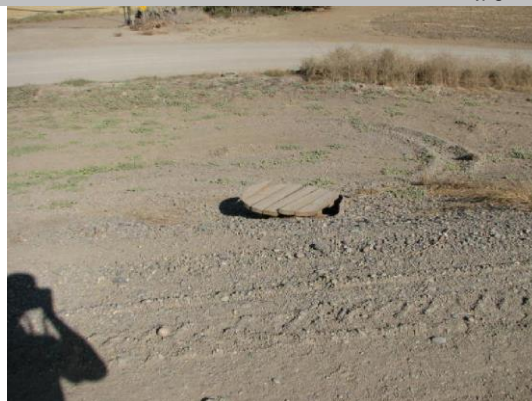
Photo 1 of 2 : UCIP_FA_2016_50423_69115.jpg

FS_ID:50423
DS_ID:17157
EP_NO: 9386
Repair Type: Non-Urgent
Crossing Status: Found
UCIP Comments: 10/17/2016 Abandoned crossing. (DWR Sutter Yard- AFreitag)5/31/2016 Abandoned crossing. Both pipe ends and slide gate inside of riser are buried.5/4/2015 Both pipe ends and slide gate in riser are plugged with soil. Crossing is inoperable.6/17/2014 Same as last inspection.12/16/2013 Same as last inspection.7/16/2013 Same as last inspection.10/11/2012 Pipe plugged with soil on both ends as well as at slide gate on WS slope. Slide gate inoperable.
FIELD_STRUCT_DESC: *ABANDONED* 24-inch corrugated metal drainage pipe through the levee, 8 feet below the crown. Slide gate in 36-inch pipe riser on the waterside (WS) shoulder. Levee turns eastward. (Automatic Board Order (ABO) issued as Permit No. 9386, 1974 - Wescott) [Additional Reference(s): DWR Levee Log, 2005. USACE Sacramento O&M Manual 132, October 1959 (HLM 11.17)]

cover on 36-inch CMP standpipe on WS slope.

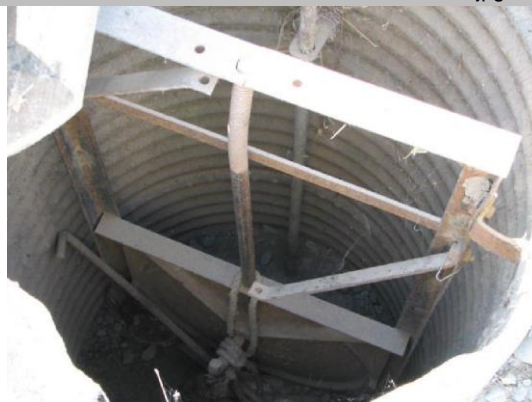
Photo 2 of 2 : UCIP_FA_2016_50423_69114.jpg

Bent and broken actuator on slide gate in 36-inch CMP. Pipe appears to be filled with soil.
